Final Engineering Report for the Hempstead Intersection Street Former Manufactured Gas Plant Site Villages of Hempstead & Garden City Nassau County, New York

**Hempstead Intersection Street
Former Manufactured Gas Plant Site
Villages of Hempstead and Garden City**

Final Engineering Report

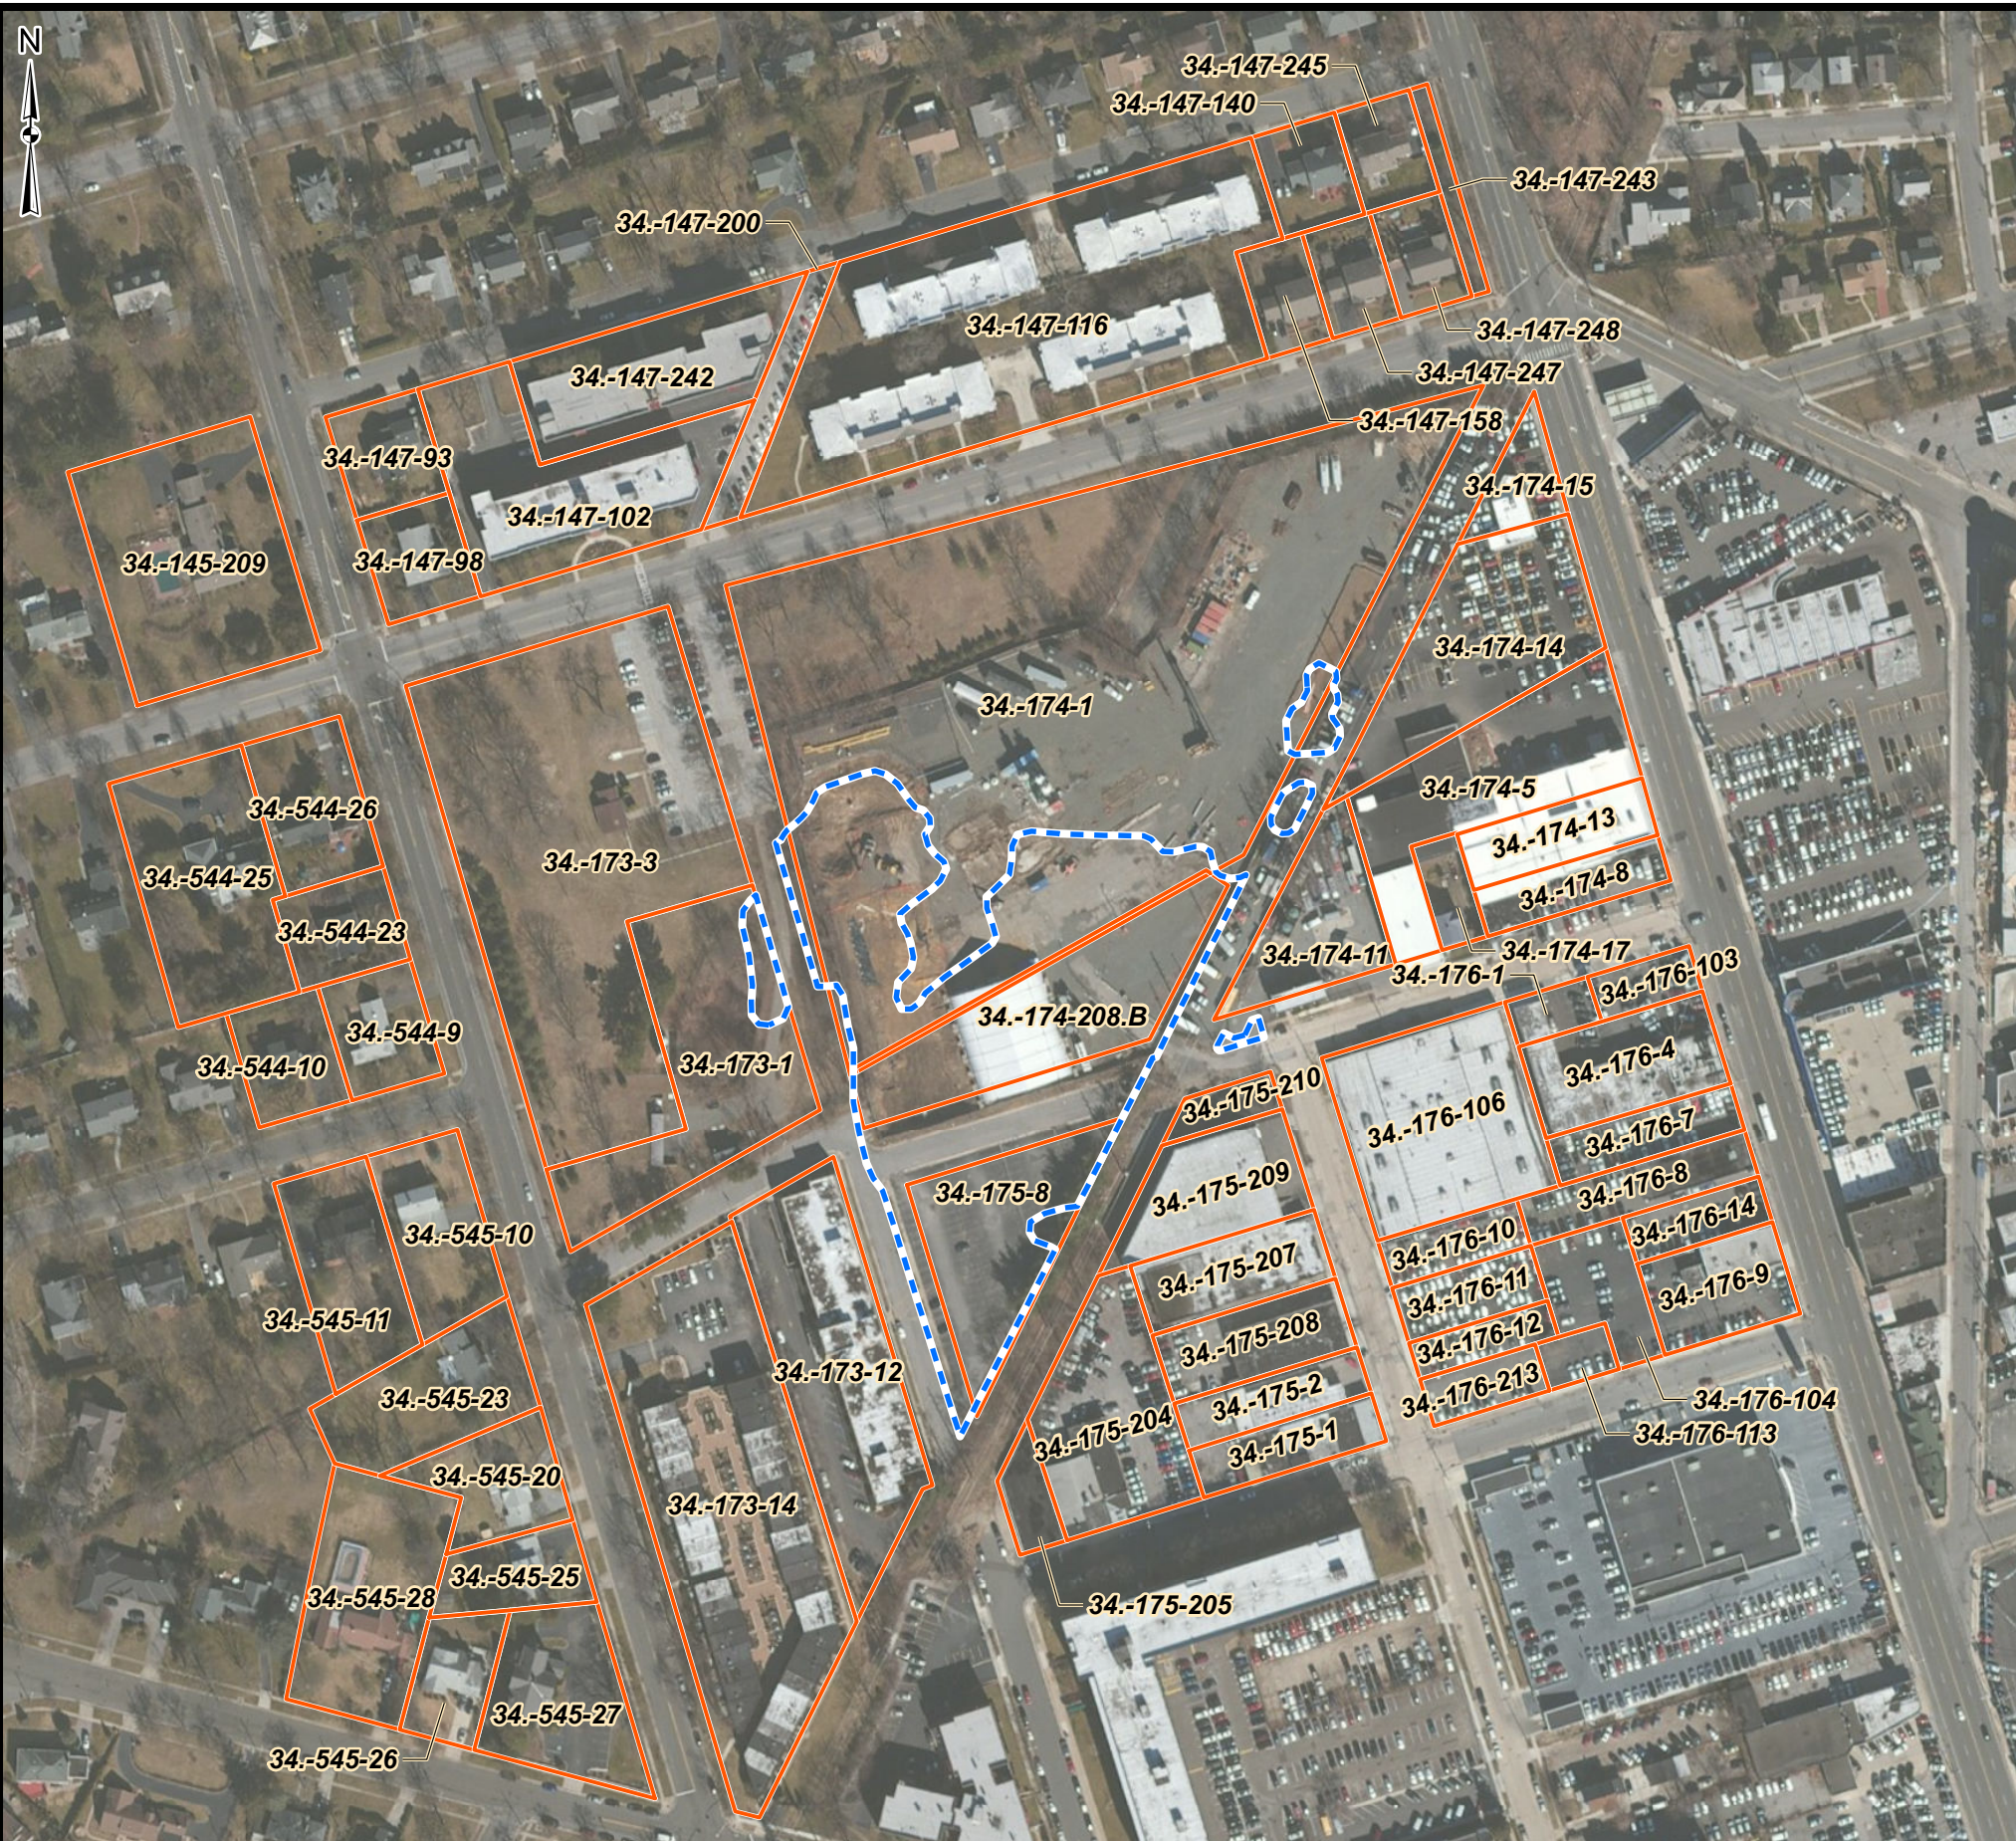
FIGURE 2

PARCEL BOUNDARIES

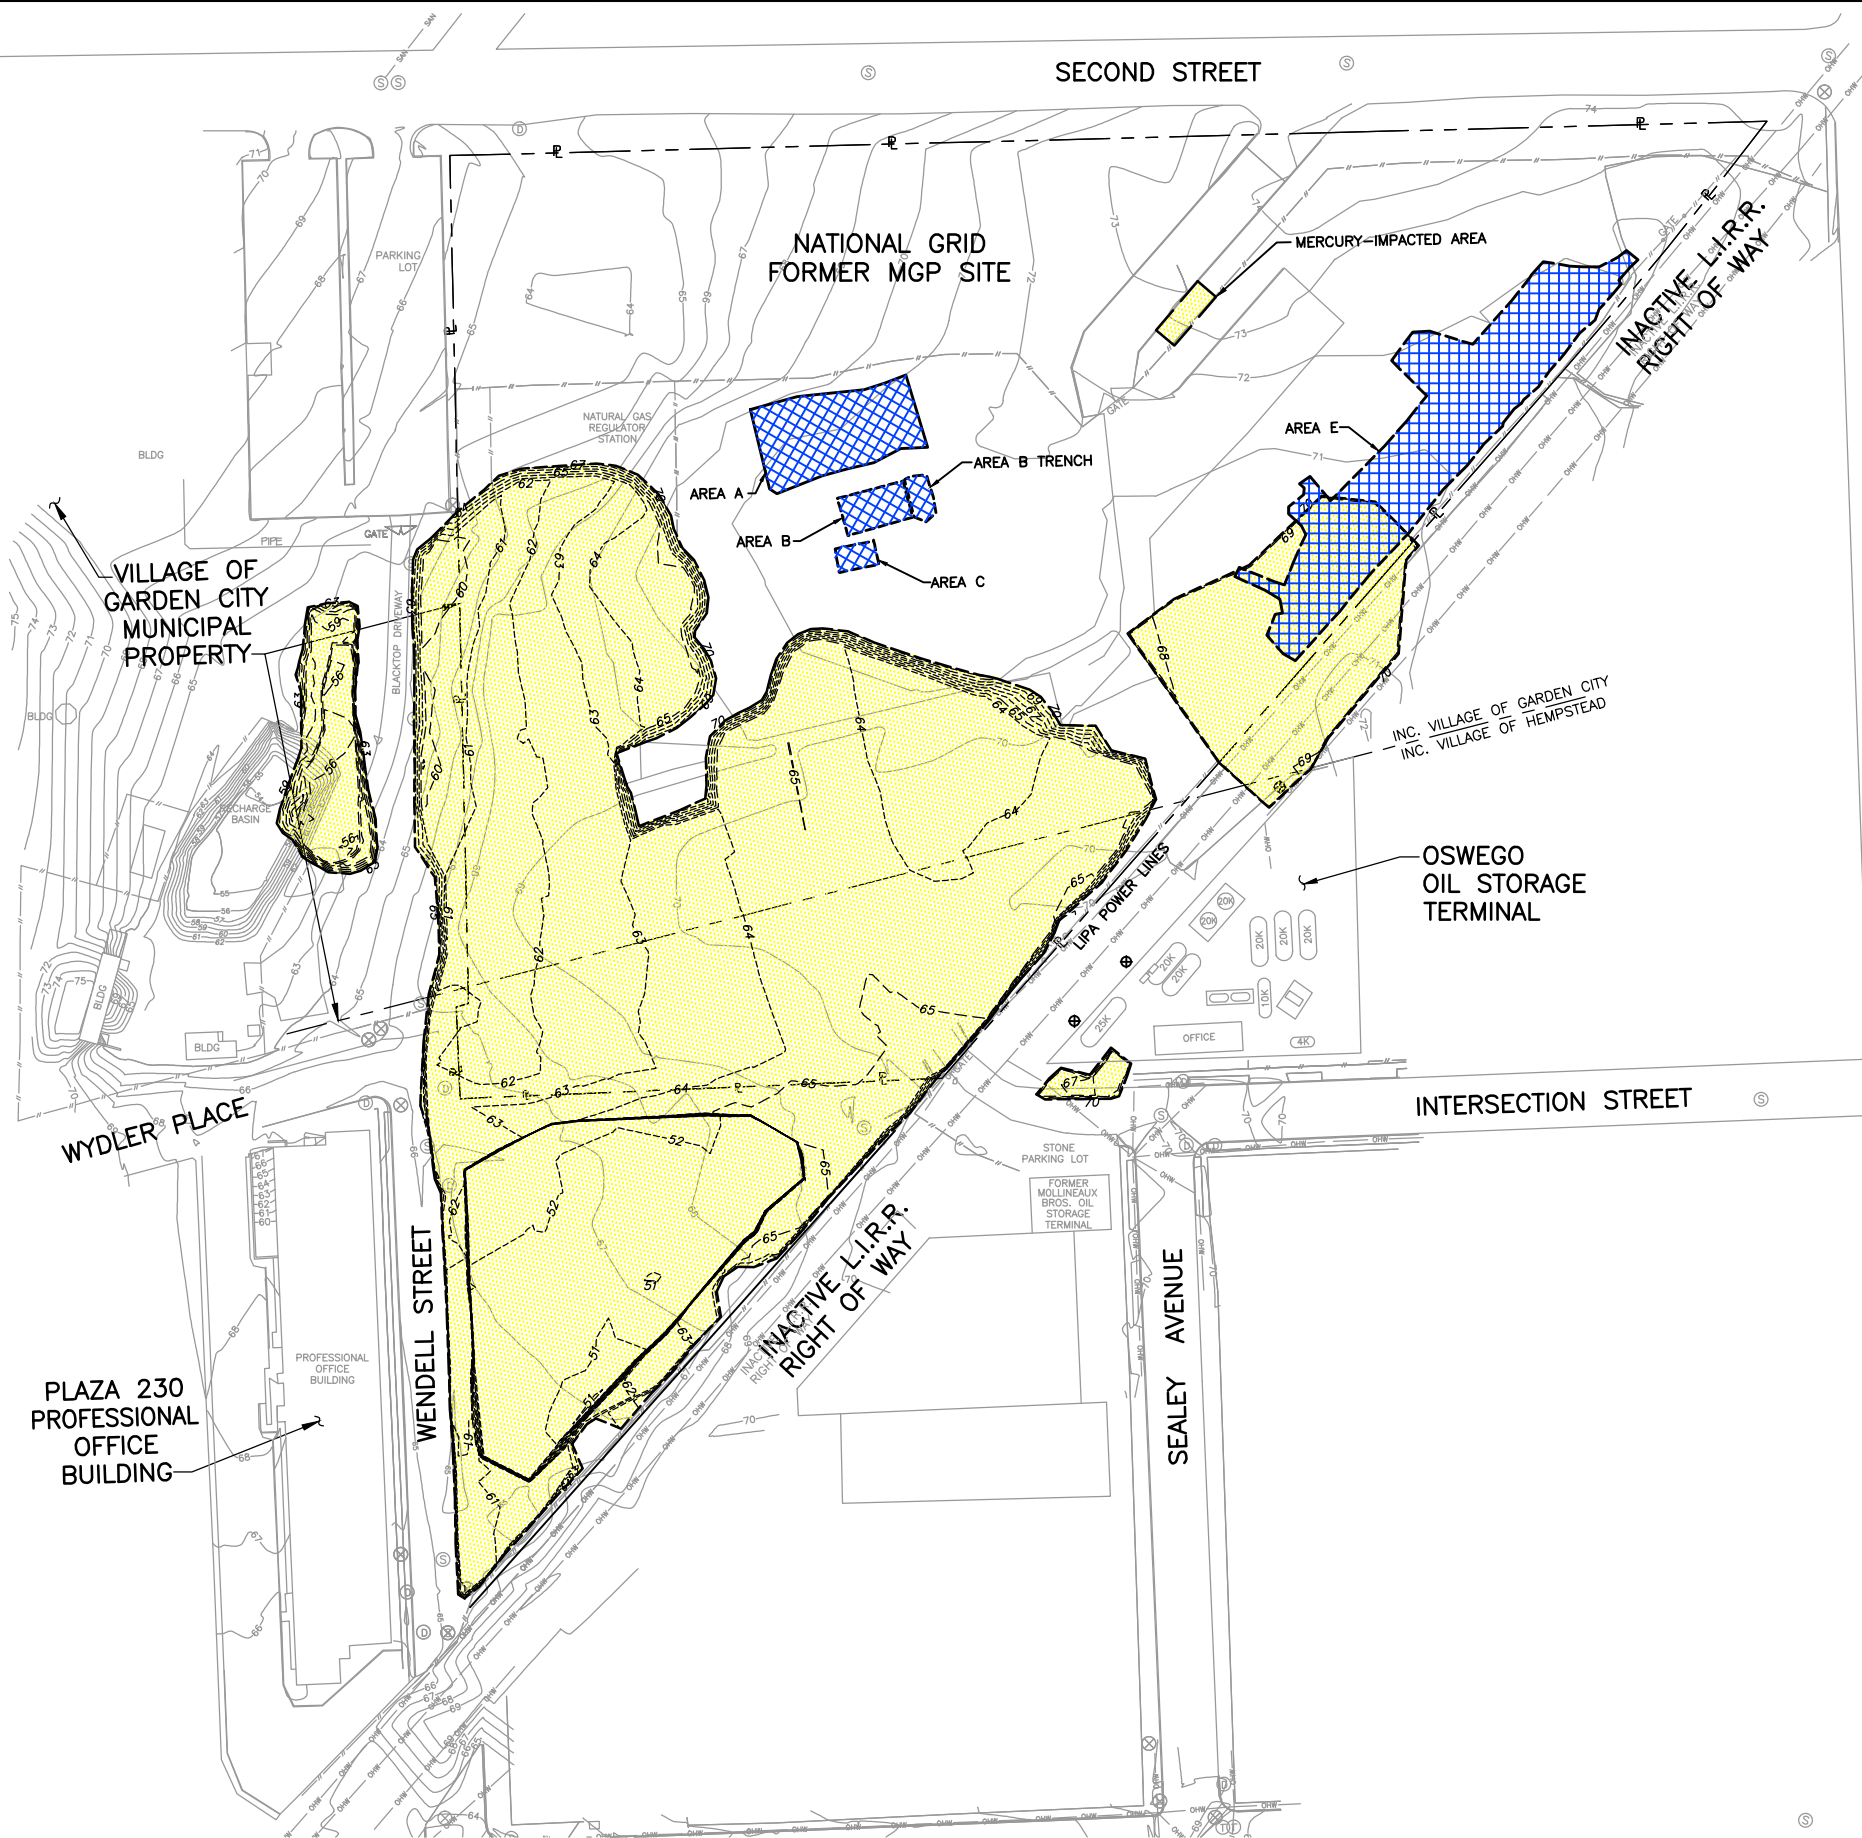
FIGURE 5

- LEGEND:**
- EXISTING PROPERTY LINE
 - POST-EXCAVATION CONTOURS, DATED 9/17/13
 - PRE-CONSTRUCTION GROUND SURFACE CONTOUR
 - EXISTING SANITARY MANHOLE
 - EXISTING STORM MANHOLE
 - EXISTING MANHOLE (UNKNOWN)
 - EXISTING MONITORING WELL
 - EXCAVATED AREA
 - IRM EXCAVATION AREAS. SOURCE: FIGURE 2-2 FROM THE IRM CONSTRUCTION COMPLETION REPORT, DATED MARCH 31, 2009.

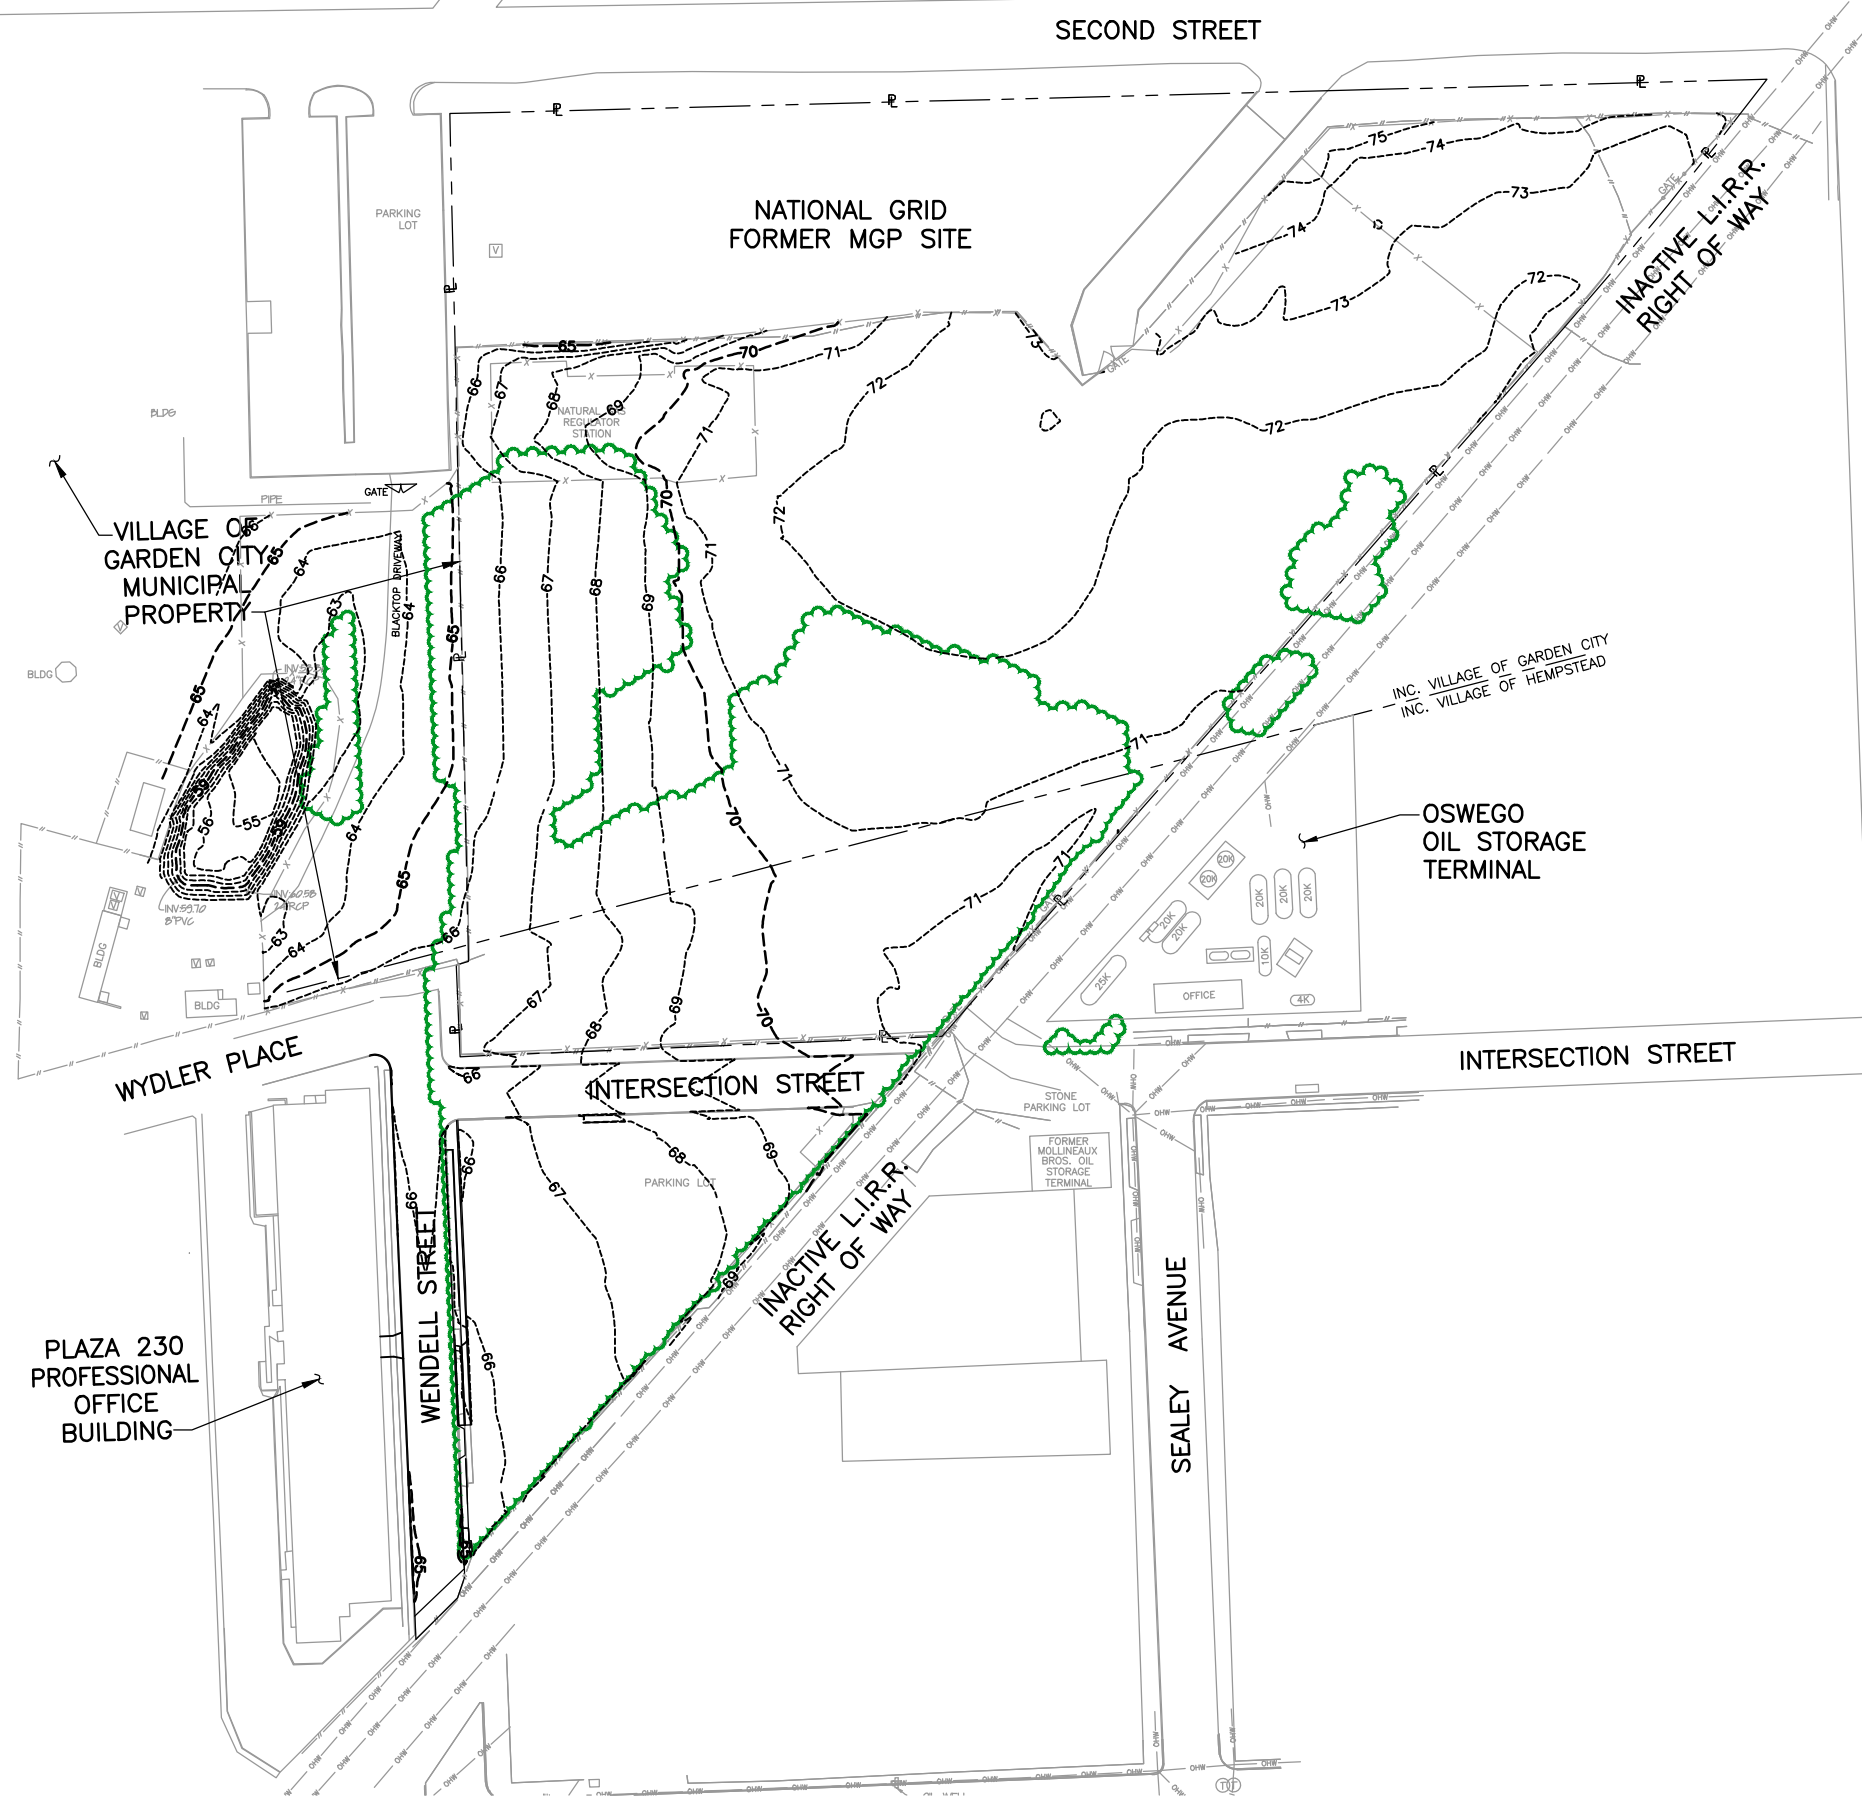
- LEGEND:**
- EXISTING FENCE
 - x- CONSTRUCTED FENCE
 - 72- FINAL GRADE CONTOUR
 - E- APPROXIMATE PROPERTY LINE
 - LOCATION OF EXISTING STRUCTURE
 - - - - - LIMIT OF MGP SOURCE MATERIAL TREATMENT

- NOTES:**
1. FINAL ELEVATIONS OBTAINED BY MASER CONSULTING, PA ON JAN. 13, 14, & 27, 2014.
 2. VERTICAL DATUM NAVD 1988.
